## Inventory of Hazardous Materials Manual Part I

| Ship / Vessel | PETROBRAS 26 |
| Type of vessel | Type of vessel Offshore submersible unit |
| IMO Number | IMO Number 8764169 |

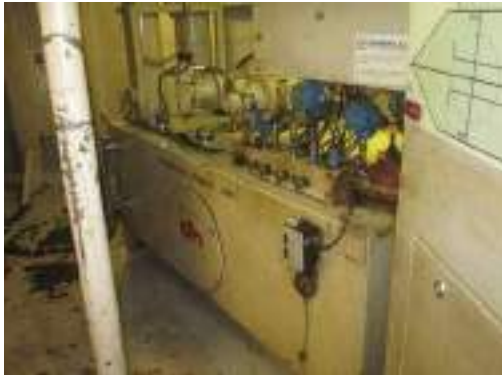
| Control Room / Control Systems-Hydraulic oil-<br>ic Unit (Ballast Control System) / Column 3<br>Frame 77 STB | | | |

| n / Zone / Deck | Expected Hazardous Materials | Check procedure | Sample No. | Sample result | Quantity | Recommended Action |
|---|---|---|---|---|---|---|
| Deck EI.25700<br>Room | PFOS | Visual | A110 | PCHM | PCHM - Quantity to be determined | |

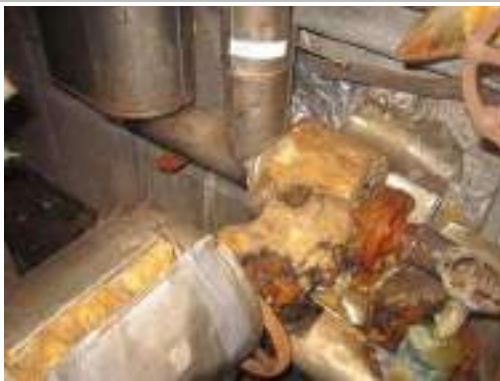
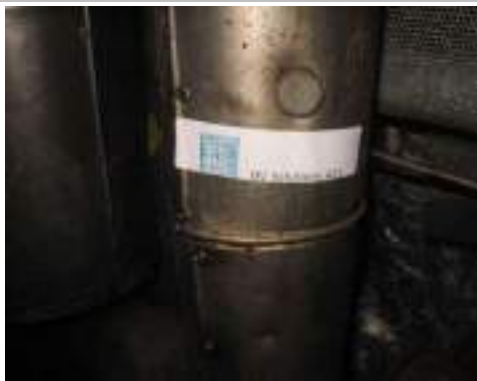
| on / Zone / Deck | Expected Hazardous Materials | Check procedure | Sample No. | Sample result | Quantity | Recommended Action |
|---|---|---|---|---|---|---|
| Ventilation-Insulation-VAC room No. 2 / piping on / Fr. 25 - STB | | | | | | |
| Deck El.34500<br>notation | PCB | Sampling | A24 | Contained, below threshold value | | |

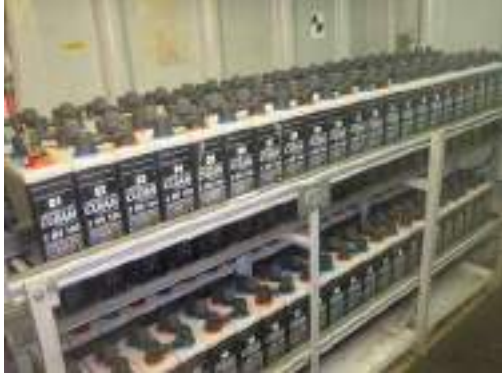
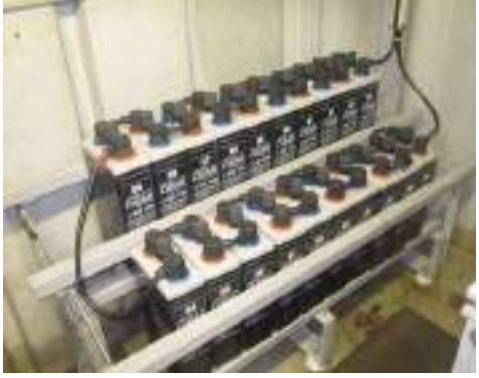
| Location / Zone / Deck | Expected Hazardous Materials | Check procedure | Sample No. | Sample result | Quantity | Recommended Action |
|---|---|---|---|---|---|---|
| Deck El.34500<br>notation | Lead | Visual | A104 | PCHM | 66 PCS | |
| Battery plates-Battery Room 2 / Frame 50 PS | | | | | | |

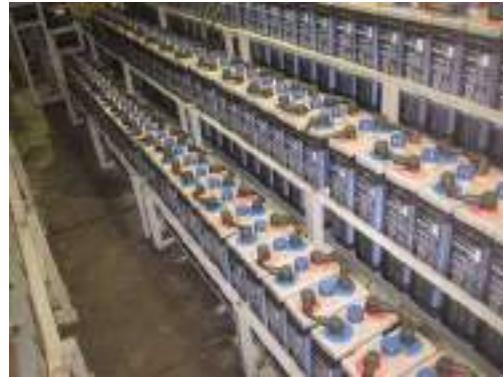
| on / Zone / Deck | Expected Hazardous Materials | Check procedure | Sample No. | Sample result | Quantity | Recommended Action |
|---|---|---|---|---|---|---|
| Deck El.34500<br>notation | Lead | Visual | A103 | PCHM | 694 PCS | |
| Battery plates-Battery Room 1 / Frame 60 PS | | | | | | |

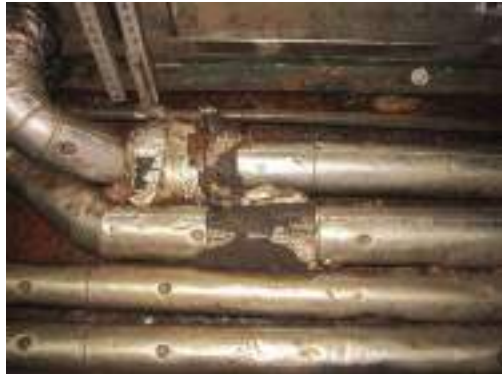
| on / Zone / Deck | Expected Hazardous Materials | Check procedure | Sample No. | Sample result | Quantity | Recommended Action |
|---|---|---|---|---|---|---|
| Room-Insulation-VAC room No. 1 / piping<br>on / Fr. 32 - STB | | | | | | |
| Deck El.43500<br>area | ODS | Sampling | A62 | Contained, below threshold value | | |

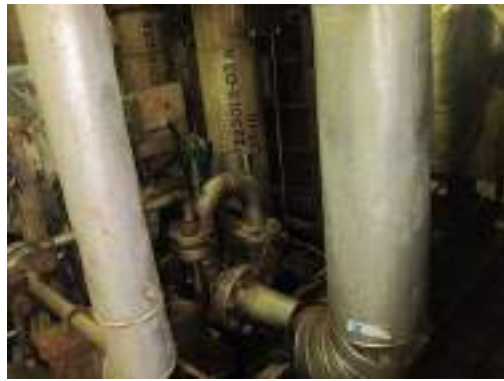
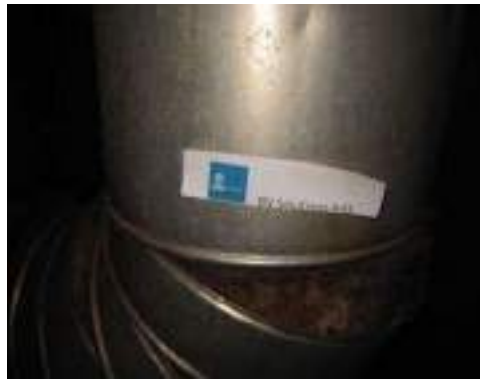
| Location / Zone / Deck | Expected Hazardous Materials | Check procedure | Sample No. | Sample result | Quantity | Risk Level Assessment | Remarks |
|---|---|---|---|---|---|---|---|
| Miscellaneous-Insulation-Exportation Pump TQ 122301B 01A) / Frame 84 PS | | | | | | | |

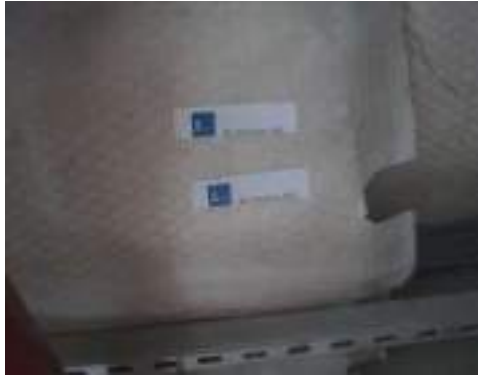
| Location / Zone / Deck | Expected Hazardous Materials | Check procedure | Sample No. | Sample result | Quantity | Risk Level Assessment | Remarks |
|---|---|---|---|---|---|---|---|
| moderation - Ceiling-Lagging material-Electrical<br>op / Frame 34 PS | | | | | | | |

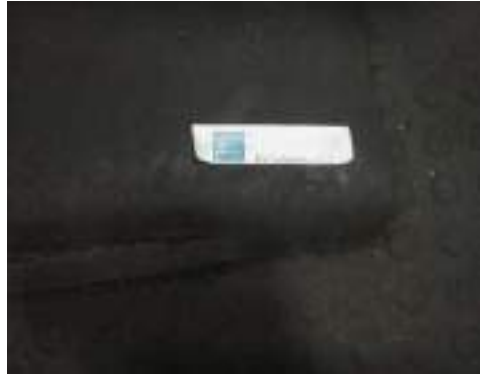
| Location / Zone / Deck | Expected Hazardous Materials | Check procedure | Sample No. | Sample result | Quantity | Risk Level Assessment | Remarks |
|---|---|---|---|---|---|---|---|
| Covering-Rubber applications-Normal Electrical Room / Frame 52 STB | | | | | | | |

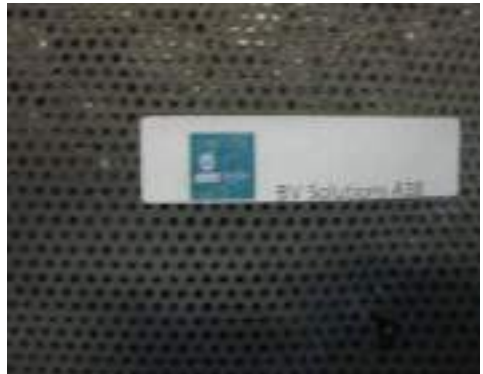
| Location / Zone / Deck | Expected Hazardous Materials | Check procedure | Sample No. | Sample result | Quantity | Risk Level Assessment | Remarks |
|---|---|---|---|---|---|---|---|
| modation - Wall-Insulation-Bulkhead insulation /<br>ancy Generator Room / Frame 38 PS | | | | | | | |

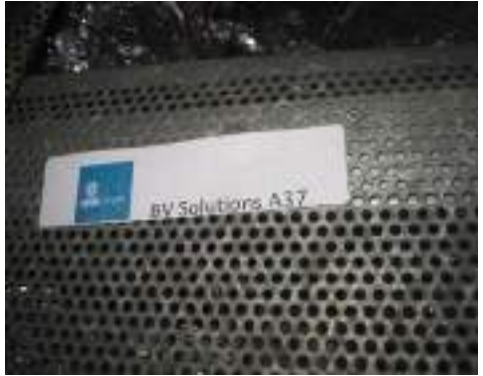
| Location / Zone / Deck | Expected Hazardous Materials | Check procedure | Sample No. | Sample result | Quantity | Risk Level Assessment | Remarks |
|---|---|---|---|---|---|---|---|
| moderation - Wall-Insulation-Bulkhead insulation /<br>ency Generator Room / Frame 42 PS | | | | | | | |

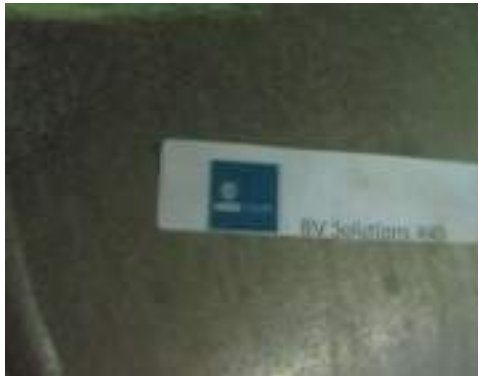
| Location / Zone / Deck | Expected Hazardous Materials | Check procedure | Sample No. | Sample result | Quantity | Risk Level Assessment | Remarks |
|---|---|---|---|---|---|---|---|
| Miscellaneous-Insulation-Exportation Pump<br>(TQ UC 122301C 01A) / Frame 84 PS | | | | | | | |

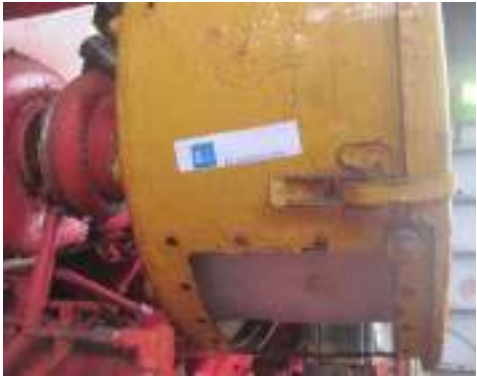
| Location / Zone / Deck | Expected Hazardous Materials | Check procedure | Sample No. | Sample result | Quantity | Risk Level Assessment | Remarks |
|---|---|---|---|---|---|---|---|
| Engine-Mineral wool-Turbocharger filter / Fire<br>Wood PS / Frame 45 PS | | | | | | | |

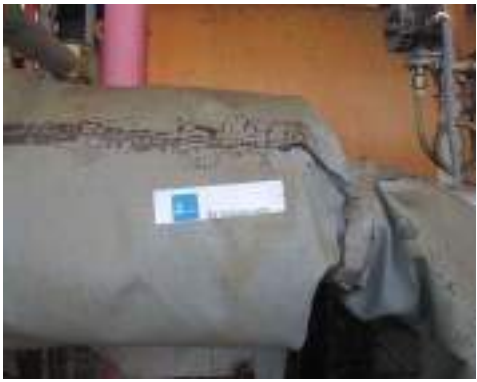
| Location / Zone / Deck | Expected Hazardous Materials | Check procedure | Sample No. | Sample result | Quantity | Risk Level Assessment | Remarks |
|---|---|---|---|---|---|---|---|
| Miscellaneous-Insulation-Piping close to Tank<br>3302 / Frame 102 PS | | | | | | | |

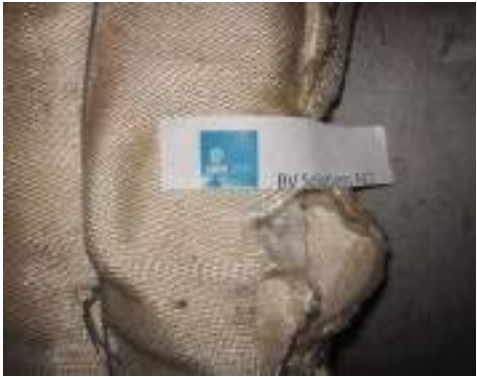
| Hot water-Insulation-Hot Water Pump Room / 109 STB<br>Deck El.34500<br>Location | | | | | | | |
| Deck El.34500 | Asbestos | Sampling | A33 | Not Contained | | | |

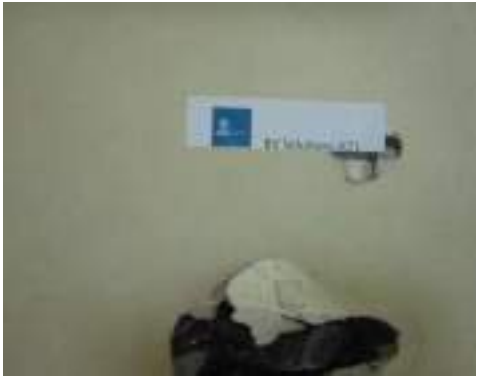
| Location - Wall-Insulation-Reading Room /<br>34 Ps | | | | | | | |
| Deck El.34500 | Asbestos | Sampling | A31 | Not Contained | | | |

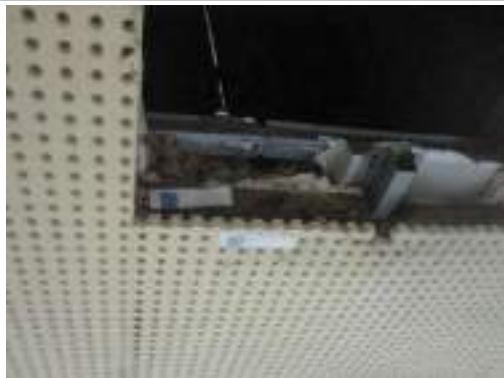
| Location: Ceiling-Insulation-Reading Room / Deck El.37500<br>Material: HBCDD | | | | | | | |
| Deck El.37500 | HBCDD | Sampling | A1 | Not Contained | | | |

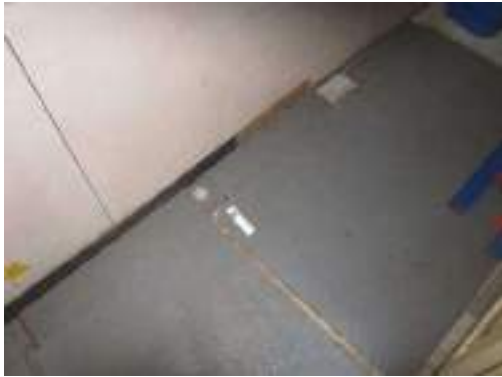
| Location - Floor-Floor covering-Control room /<br>Deck El.37500<br>Area | | | | | | |
| Deck El.37500 | TBT | Sampling | A60 | Not Contained | | |
